**GOVERNMENT OF ST. LUCIA
MINISTRY OF PLANNING**

**ENERGY AUDIT OF
GREAHAM LOUISY BUILDING
CASTRIES ST. LUCIA**

February 2001

Lewis Engineering Inc.

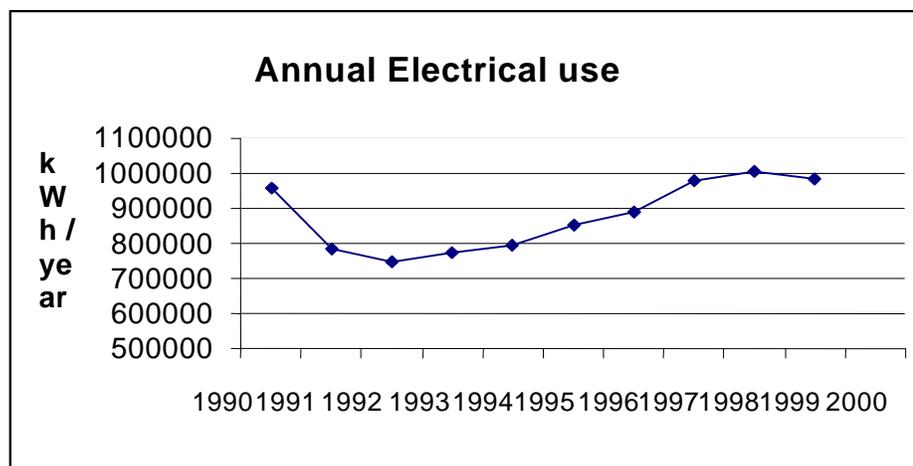
Annual energy use for the last ten years is shown above. The obvious reduction in use starting in 1991 is due to a staff initiative to shut off lights and equipment over night. Energy use began to rise again towards the end of the 1990s, likely reflecting an increase in office equipment (computers etc.) and more people in the building.
